Unexpected early-onset transvalvular regurgitation after transcatheter aortic valve implantation: salvaged by simple balloon touch-up

Sakiko Gohbara¹ · Yasuhide Mochizuki¹ · Seita Kondo¹ · Yumi Yamamoto¹ · Hiroto Fukuoka¹ · Toshiro Shinke¹

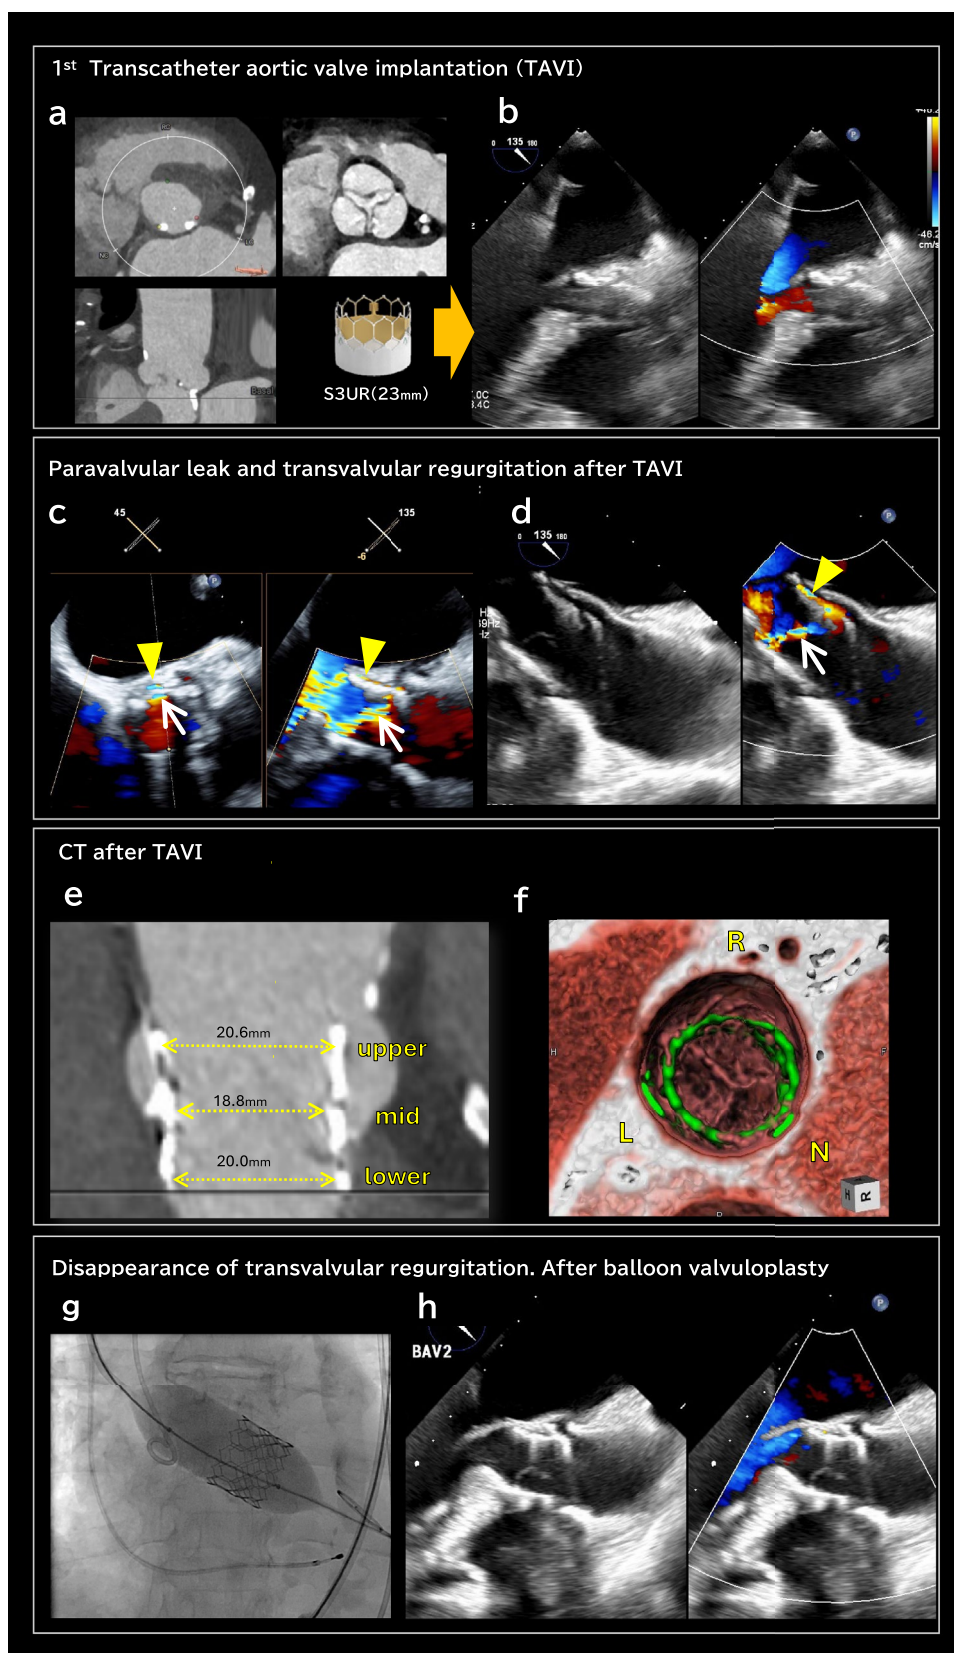
Fig. 1 **a** TEE shows bulky calcified protrusion from the aortic annulus into the left ventricular outflow tract, **b** TAVI was completed without significant residual aortic regurgitation, **c** TEE at heart failure onset clearly depicts both PVL (yellow arrowhead) and TVR (white arrow) in biplane short- and long-axis views, **d** Suboptimal expansion of the TAVI valve is observed, with an eccentric TVR jet arising near the PVL origin, **e** Contrast-enhanced CT demonstrated shortening of the stent diameter at the mid-level, **f** No morphological abnormalities of the valve leaflets were observed on 3-dimensional volume-rendered image, **g** Balloon valvuloplasty at the second TAVI procedure, **h** TVR completely disappeared on TEE after balloon valvuloplasty. *TEE* transesophageal echocardiography, *TAVI* transcatheter aortic valve implantation, *CT* computed tomography, *PVL* paravalvular leak, *TVR* transvalvular regurgitation

An 87-year-old woman with symptomatic severe aortic stenosis, whose aortic valve had three cusps, underwent transcatheter aortic valve implantation (TAVI) using a 23 mm Sapien 3 Ultra RESILIA valve (Edwards Lifesciences, Irvine, CA, USA). The procedure was performed under general anesthesia and transesophageal echocardiography (TEE) guidance via a transfemoral approach. Due to bulky calcification in the left ventricular outflow tract detected by computed tomography (CT) (Fig. 1a), the valve was implanted with 10% underfilling (−2 mL), which resulted in an oversizing rate of approximately −4% based on the CT-measured aortic annulus area of 420 mm². The prosthetic valve was deployed at the intended position under rapid pacing. Post-deployment TEE revealed a noticeable paravalvular leak (PVL), prompting balloon post-dilation, which reduced the PVL to an acceptable level (Fig. 1b, Video S1). On postoperative day 2, the patient developed marked oliguria, pulmonary wheezing, and radiographic evidence of pulmonary congestion. She was diagnosed with acute decompensated heart failure (HF). Transthoracic echocardiography showed moderate aortic regurgitation, and TEE revealed not only PVL but also an eccentric regurgitant jet through the prosthetic valve, suggestive of transvalvular regurgitation (TVR) (Fig. 1c, d, Video S2). Contrast-enhanced CT showed that the stent-valve diameter at mid-level was 18.8 mm, indicating under-expansion (Fig. 1e), but we could not demonstrate the presence of leaflet malcoaptation or bending (Fig. 1f, Video S3). A multidisciplinary heart-team conference concluded that a valve-in-valve procedure using the same valve is essential for the treatment of HF. Intraoperative TEE during the second procedure revealed worsening PVL compared

to the prior procedure. Therefore, a 23 mm balloon valvuloplasty was performed for pre-dilation (Fig. 1g). Surprisingly, it not only reduced PVL but also completely eliminated the TVR which had been the primary cause of the patient's HF (Fig. 1h, Video S4). As the TVR resolved completely, the implantation of a second valve was deemed unnecessary. The postoperative course was uneventful, and the patient was discharged on postoperative day 24 after successful management of HF. Early-onset TVR after TAVI may result from various mechanisms including leaflet malcoaptation, cusp injury, oversizing, or excessive ballooning [1]. In this case, delayed recoil of the valve frame may have led to transient leaflet malalignment. To our knowledge, this is the first report describing such a phenomenon. Intraoperative TEE sequentially showed stent-valve diameters of 15.6 mm after the first implantation, 17.9 mm after post-dilatation, and 16.8 mm before and 17.5 mm after balloon dilatation in the second session. The observed fluctuation in diameters is suggestive of stent recoil. Although the exact etiology remained unclear, this case highlights that balloon re-dilatation can be an effective troubleshooting option for acute TVR following TAVI.
